# Warren Town Council

Warren Town Beach

Sanitary Investigation Results

May 22, 2008

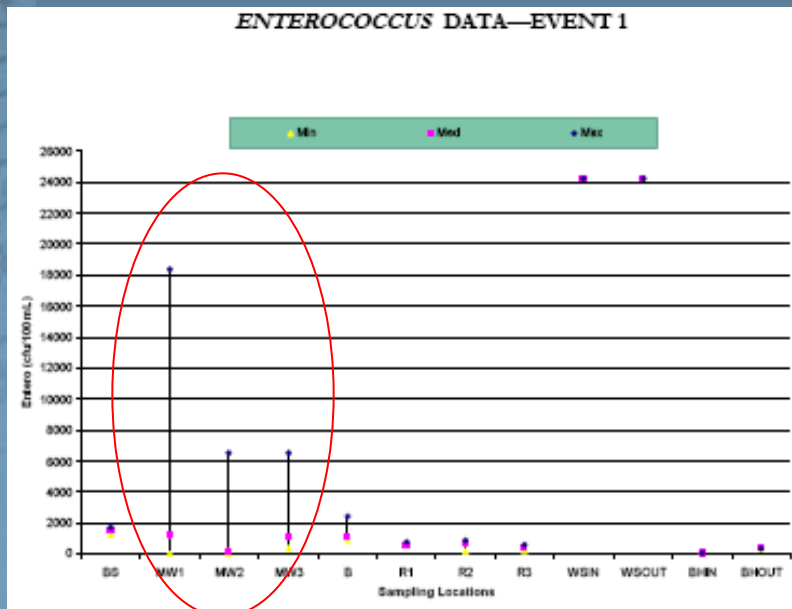
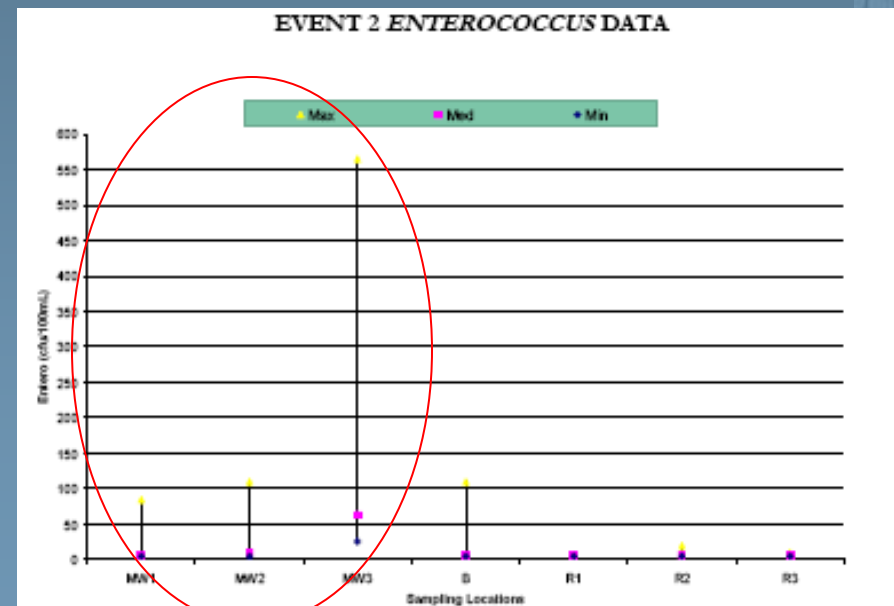
- Problem is wet-weather related, but not always.
- Unusually high levels of bacteria and signature sanitary contaminants in groundwater.

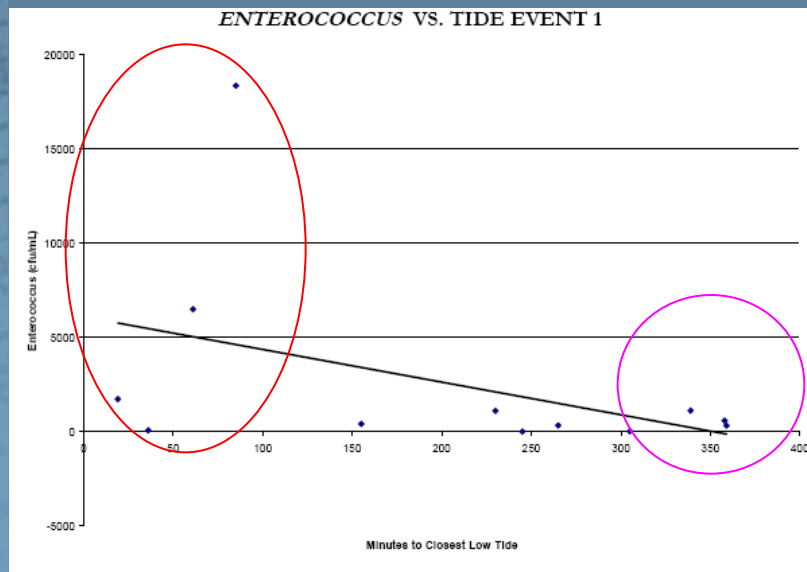
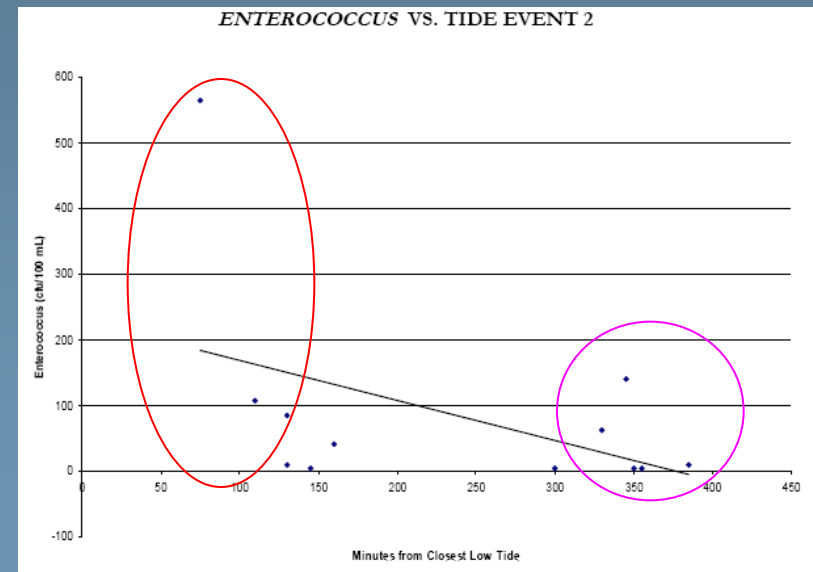
- Groundwater gradient at low tide draws subsurface contamination to the beach.

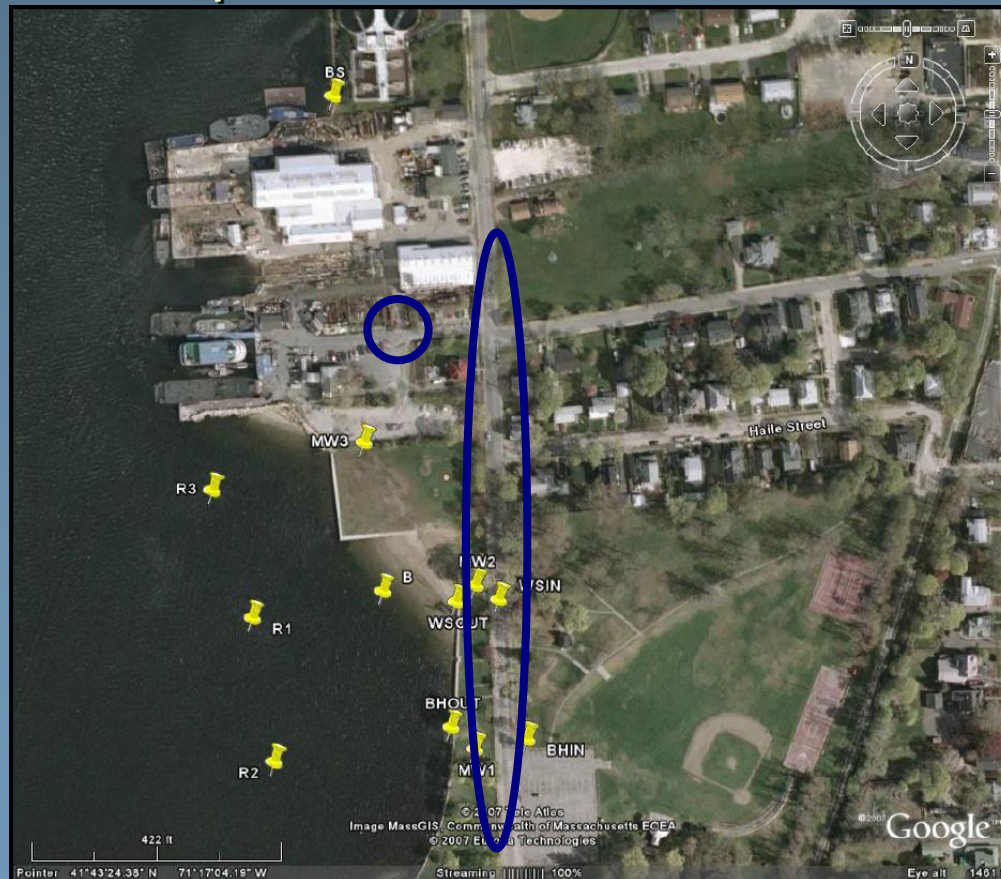
- Potential subsurface sources—Water St sewers and Blount Pumpout Tank.

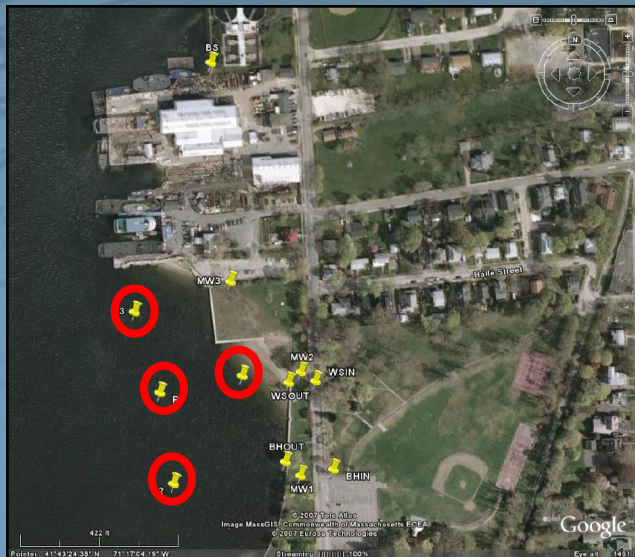
**RHODAMINE DYE CONCENTRATION  
OBSERVED AT BEACH AND RIVER LOCATIONS**

- Dye-testing shows contaminants tend to persist in the beach area.
- Based on dye-testing results, primary sources of impact are likely to be close to the beach.

Time Since Dye Injection	Beach (Dye in ppb)	R1 (Dye in ppb)	R2 (Dye in ppb)	R3 (Dye in ppb)
Hour 1	7.30	5.10	5.06	3.12
Hour 6	8.00	7.89	7.77	3.44
Hour 18	6.00	4.78	3.55	3.14
Hour 24	3.63	2.12	0.75	4.73
Hour 30	3.85	2.21	0.15	4.81

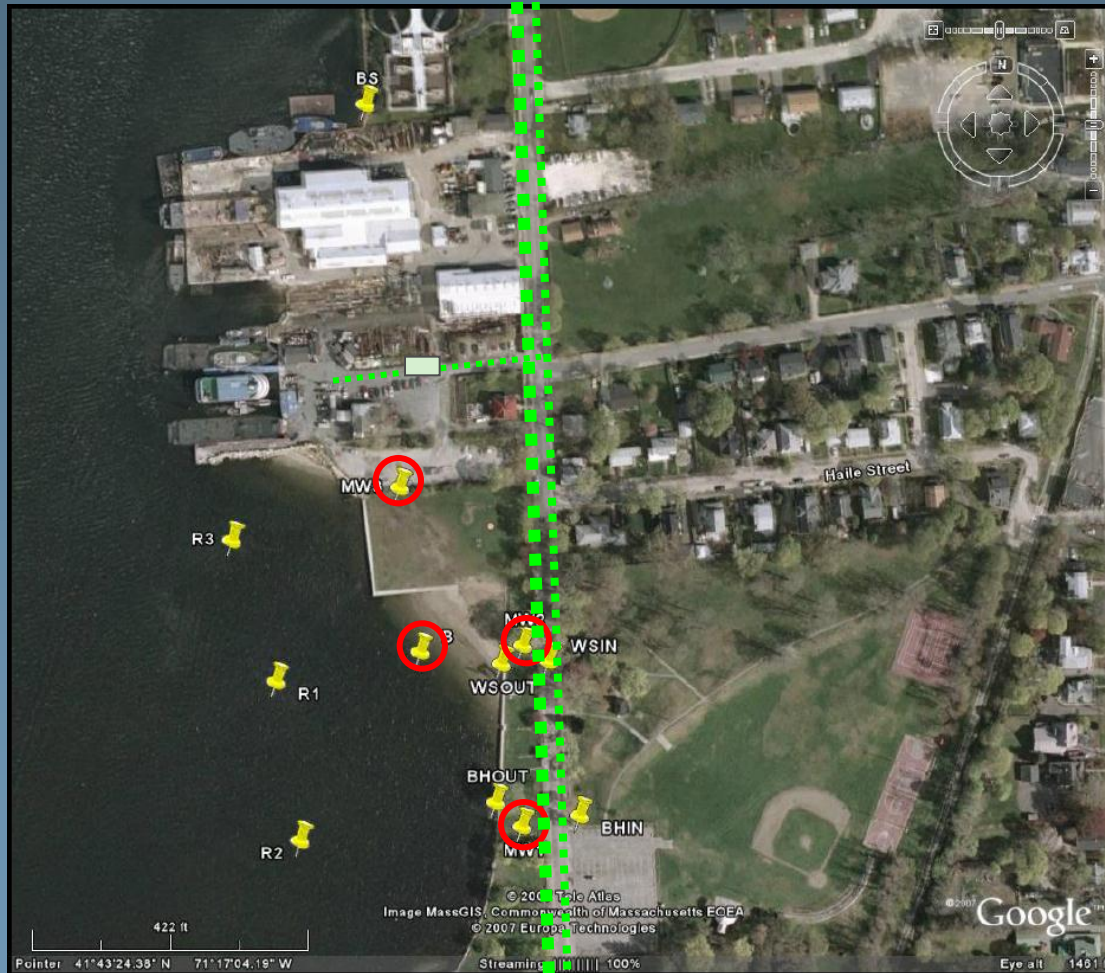
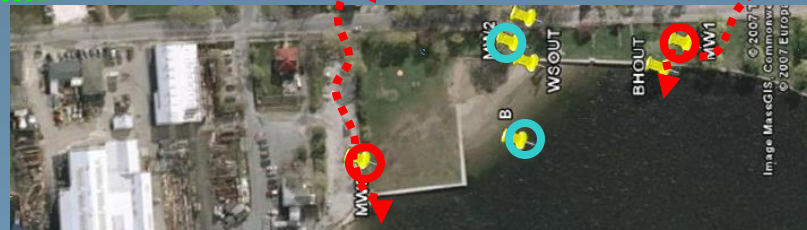
# 12" Line Dye-Test Results

**~1700 feet**

*Partially Lined ~900 feet*

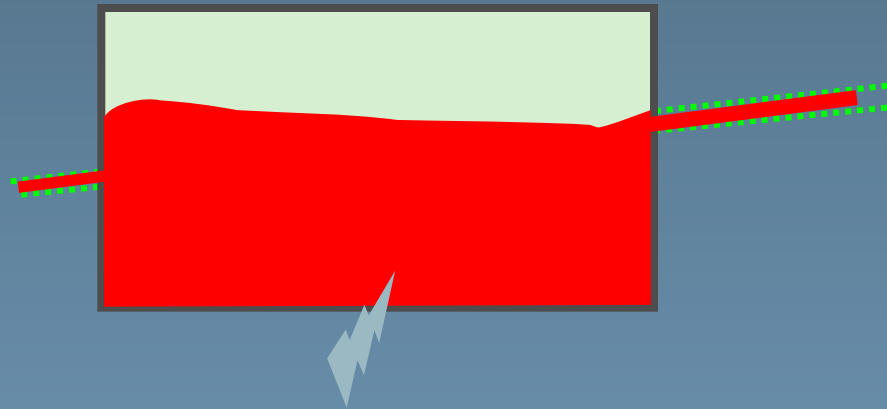
## Leak Test

8 hours later = 6-inch loss

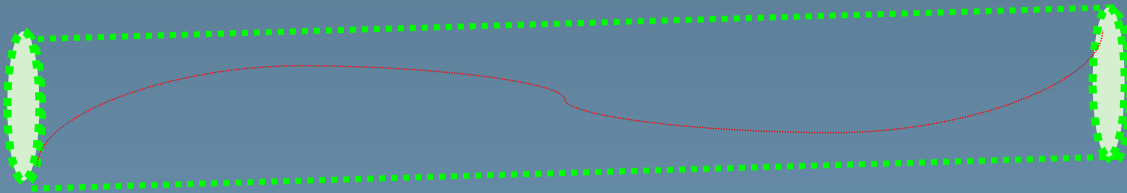
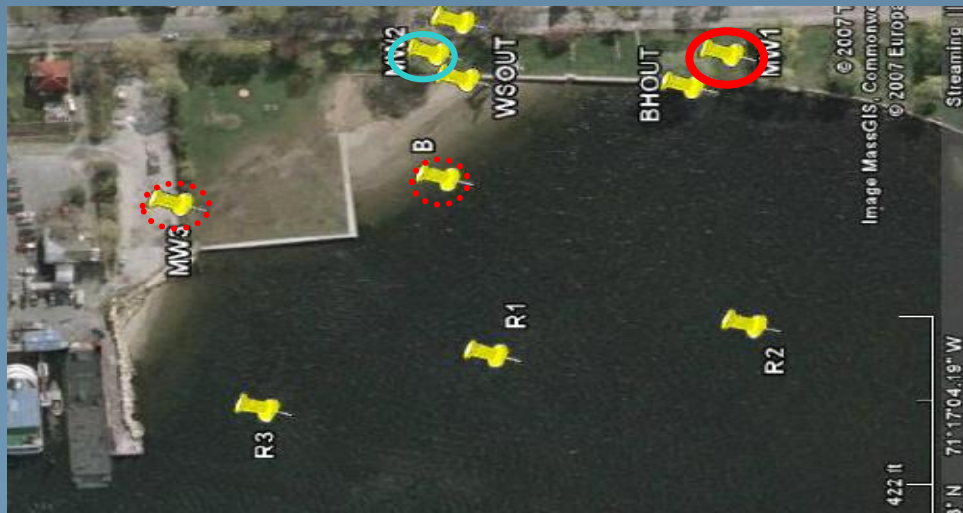
# 24" Line Dye-Test Results

← ***~1100 feet*** →

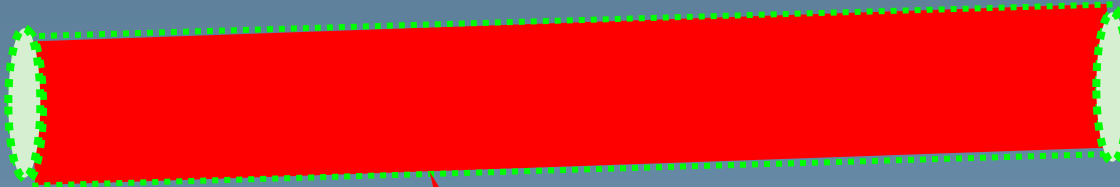
# 24" Line Dye-Test Observations

Dye backflowing from  
12-inch line  
connection

***~1100 feet***

- Supported by TV investigation that shows infiltration into the 24-inch line.

***8 hours later = 1/2 empty***

- Fully line 12-inch, 24-inch, 27-inch lines.
- Redo lining, but attempt to reuse existing lining.
- Replace sewers.
- Line as a temporary measure, then replace sewers.
